# A sparkling **DIAMOND**

## Which Snapshot: 1983 Diamond RV Autocruiser

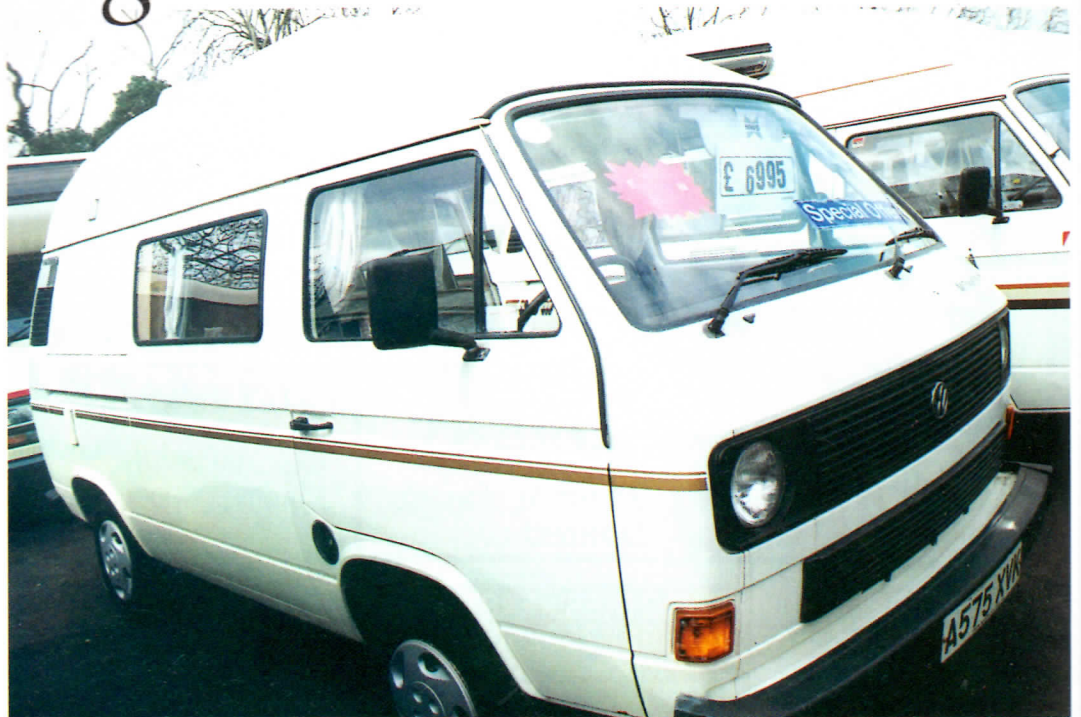
**Just another VW conversion? Actually, no. This Diamond RV Autocruiser has a surprisingly comprehensive specification and an unusual layout.**

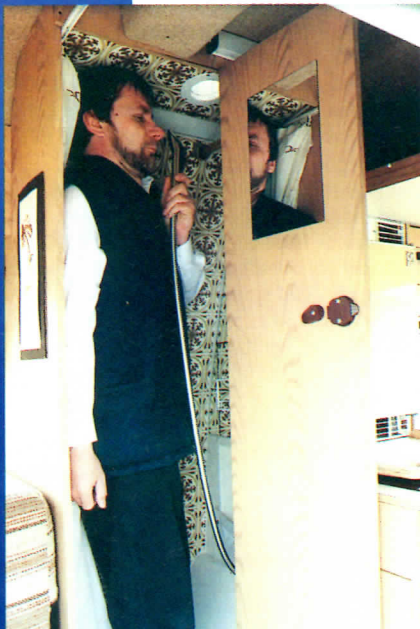
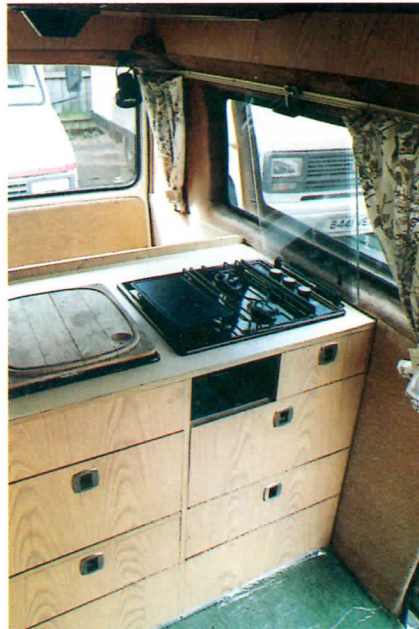
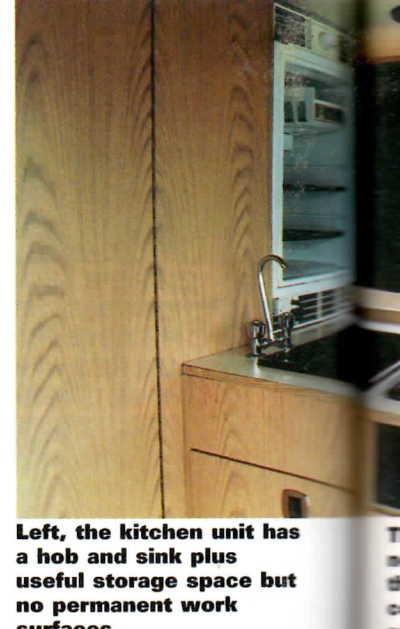
**A shower in a VW conversion — it is possible. However, the writer demonstrates that showering would be akin to shaving and the likelihood of getting the carpet wet would be high.**

**Left, the kitchen unit has a hob and sink plus useful storage space but no permanent work surfaces.**

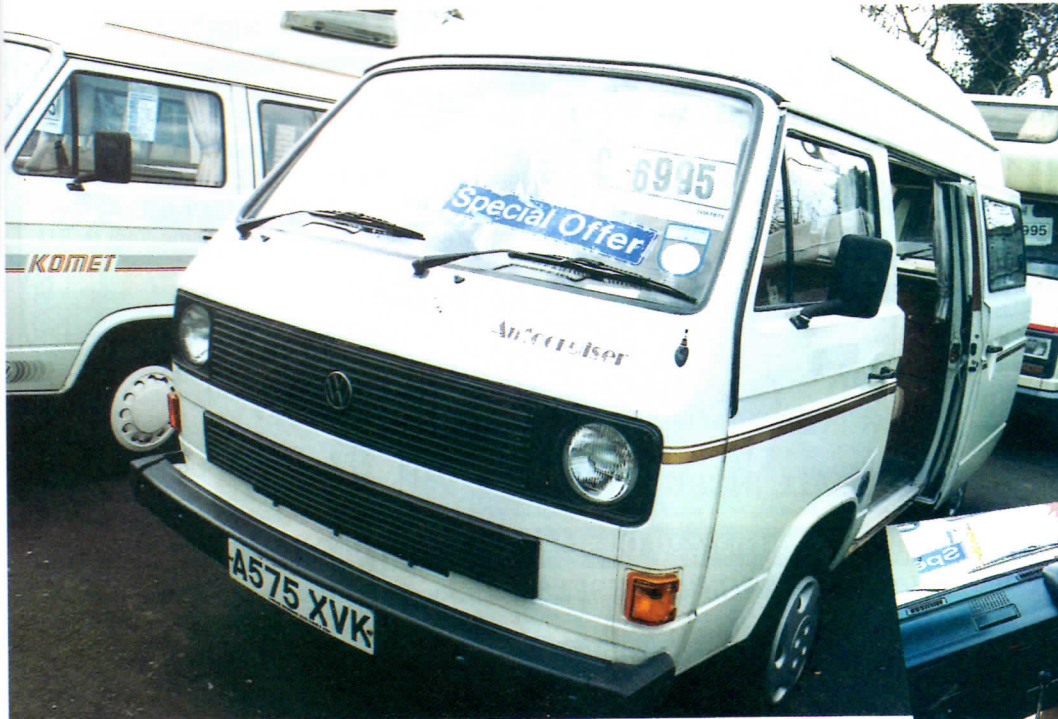
**Driver's seat is torn and would benefit from a seat cover. Mileage of 50,000 appears genuine. VW engine should last.**

The driver's seat had fared less well, but a seat cover would be a cheap way to hide the torn fabric. Other things to note inside are the Zig unit for a mains supply when on a suitably equipped site, the locker above the cabin area and a good number of lights —

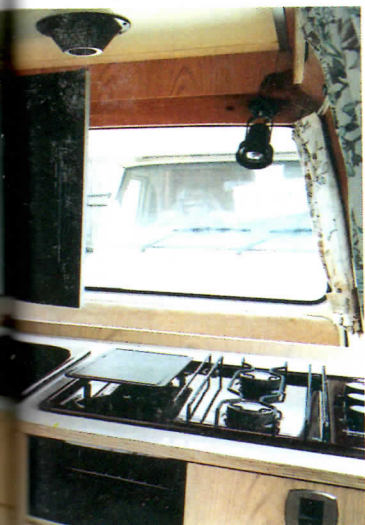
**The fridge is to one side — not easily accessible. Note the table stored above the cooking area and the handy spotlight.**
